NASA TM-82428

FRACTURE ANALYSIS OF HPOTP BEARING BALLS

By Biliyar N. Bhat
Materials and Processes Laboratory

May 1981

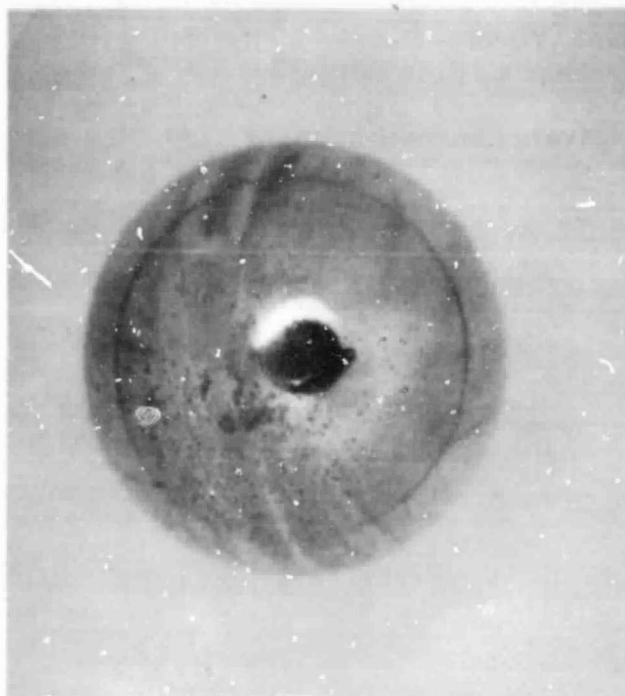
A total of four HPOTP No. 3 bearing balls were examined, two with spalls and two without. The origin and surface characteristics of these balls are given in Table 1. Ball No. 1 showed no visible surface cracks or spalls but had visible wear tracks and numerous shallow pits (Fig. 1). In order to determine if the ball had any subsurface cracks, a nondestructive evaluation technique was used. In this technique, the ball was placed in an eddy current probe operating at 500 KHz and tested. A subsurface flaw was detected. The flaw was located on the wear tracks. Subsequent to the eddy probe examination, the ball was mounted in epoxy and sectioned parallel to the wear track, using a diamond cut-off device. The cross section was polished, etched in Vilella's reagent [4] and examined under an

FIGURE 1. Photomicrograph of Ball No. 1 from HPOTP 2502, Engine 0008. Note the pits and wear tracks. The black dot was used to minimize glare. Photomicrographs of sections of this ball are given in Figures 2, 3, and 4.

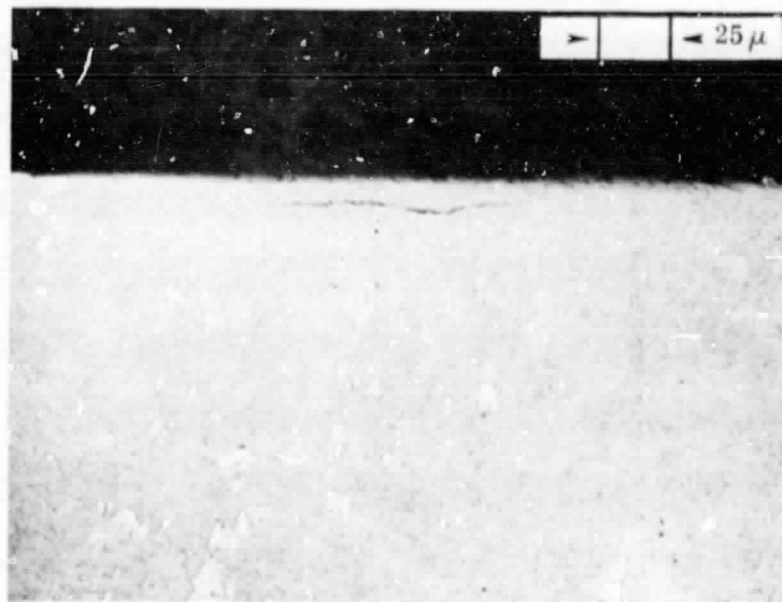
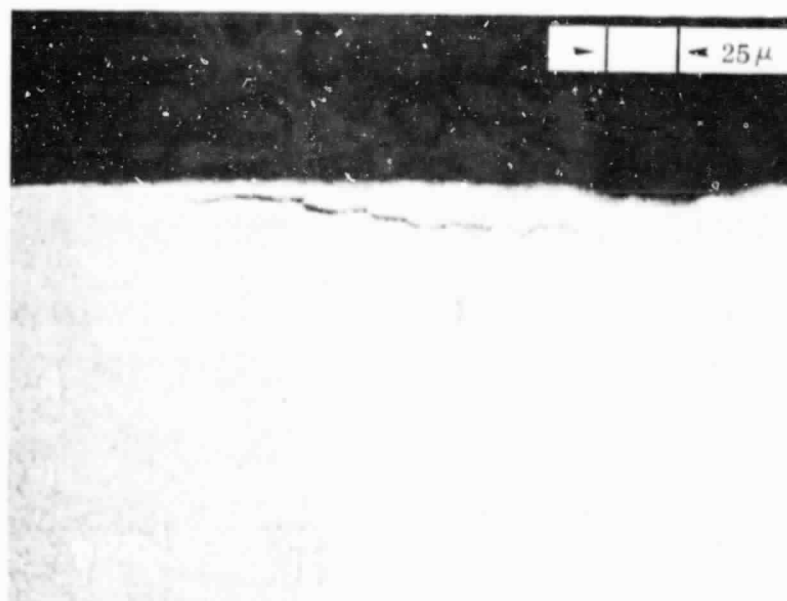
Photomicrographs of cracks in ball No. 1 are presented in Figures 2 through 4. Figure 2 shows two photomicrographs of a subsurface crack at two different positions. The position 2 is 0.25 mm (0.010 in.) from position 1. This crack was correctly located by the eddy probe. Figures 3 and 4 show different types of surface cracks present in the ball. It should be noted that all these cracks are very shallow, less than .025 mm (0.001 in.) deep. They appear to meet the surface at relatively small angles (approximately 20°).

It is significant that the subsurface crack in ball No. 1 (Fig. 2) was correctly located by the eddy probe technique. This result shows that it is possible to determine the subsurface cracks in balls without having to section them. Hence eddy current probe technique may be used to nondestructively identify balls having subsurface flaws existing at the time of manufacture or subsequently induced in operation.

It is also significant that the subsurface crack was actually located under the wear track. This location is to be expected because the bearing material under the wear track is subjected to cyclic stresses. According to the Palmgren theory [5] fatigue cracks initiate under stress at locations of maximum shear stress which is usually subsurface, typically 0.075 to 0.203 mm (0.003 to 0.008 in.), depending on the magnitude of Hertzian stress [3]. Under conditions of pure rolling, high stresses initiate fatigue cracks at deep locations. With the addition of frictional or sliding forces, planes of maximum shear stress move closer to the surface [6]. Sliding forces of sufficient magnitude can cause cracks to originate at the surface and significantly reduce bearing life. The cracks in Figure 3 appear to be surface initiated. The cracks shown in Figure 4 are in advanced stages and it is difficult to tell their origin. Interestingly, all cracks in this ball were very shallow, less than 0.001 in. from the surface. This result suggests two possible mechanisms of cracking: (1) Hertzian stresses are very low such that crack initiation occurs at very shallow depths; (2) Hertzian stresses are high but the coefficient of friction is also high such that the plane of maximum shear stress is very close to the surface. The author favors the latter mechanism because, if the Hertzian stresses were indeed low, the bearing life would have been very long (hundreds of hours). However, the ball in question had seen only 1904 sec of operation in the turbopump (7) and subsurface crack initiation is not expected in such a short time period under normal loading conditions. On the other hand, surface cracks are expected to occur in a short time under abnormally high loading conditions in combination with poor lubrication (high coefficient of friction). Therefore, it appears that the cracks in this ball were initiated under conditions of high stresses and high coefficient of friction. The high coefficient of friction was probably due to the failure of teflon transfer film lubrication. If this hypothesis is correct, it should be possible to increase the life of this bearing by improving lubrication.

Figure 2. Subsurface crack in HPOTP 2502 bearing ball from Engine 0008. Crack depth approximately 0.075 to 0.203 mm (0.0003 to 0.0008 in.)

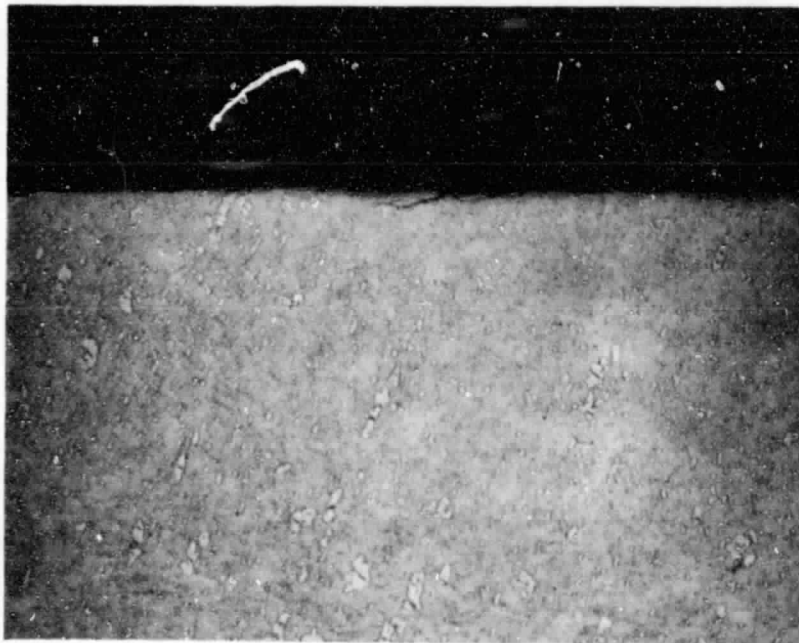
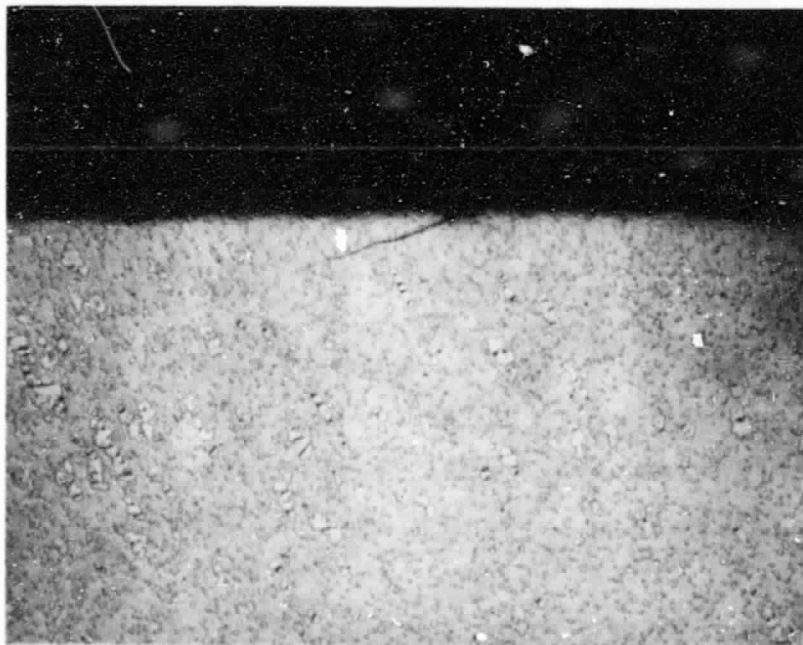
Figure 3. Surface cracks in HPOTP 2502 bearing ball from Engine 0008.

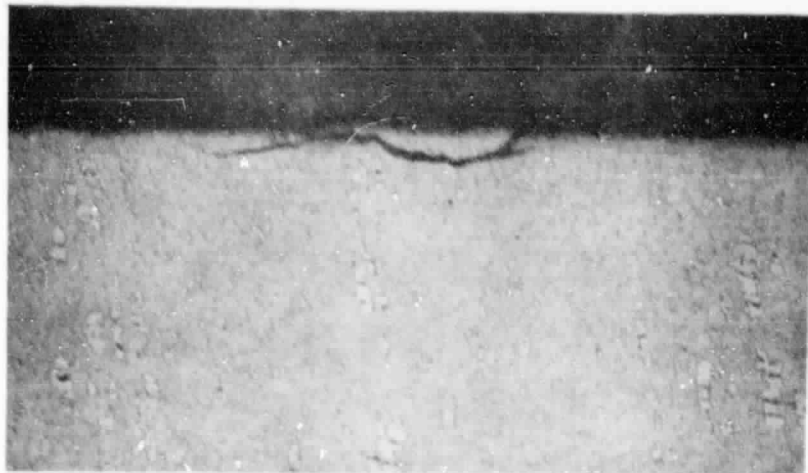
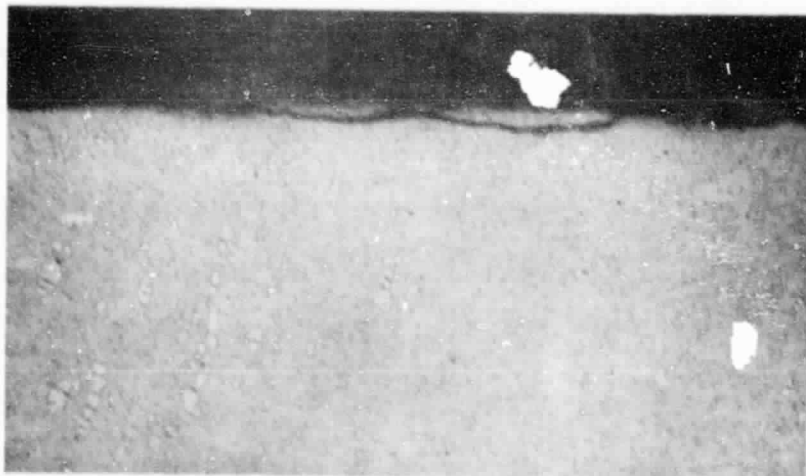
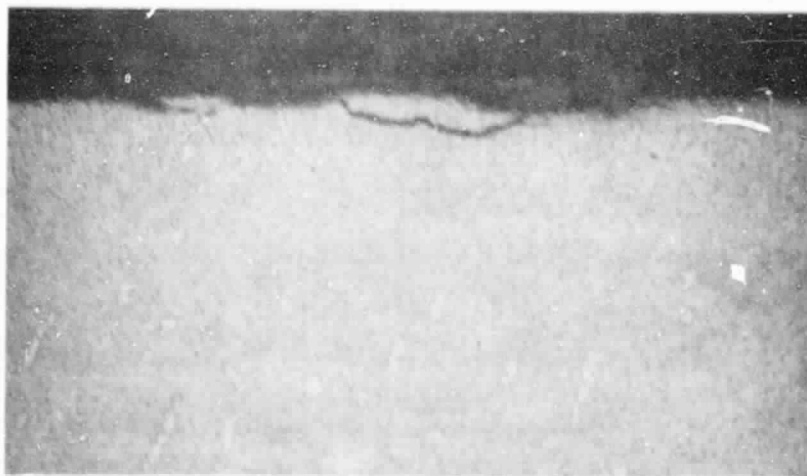
Figure 4. Surface cracks in HPOTP 2502 bearing ball from Engine 0008.

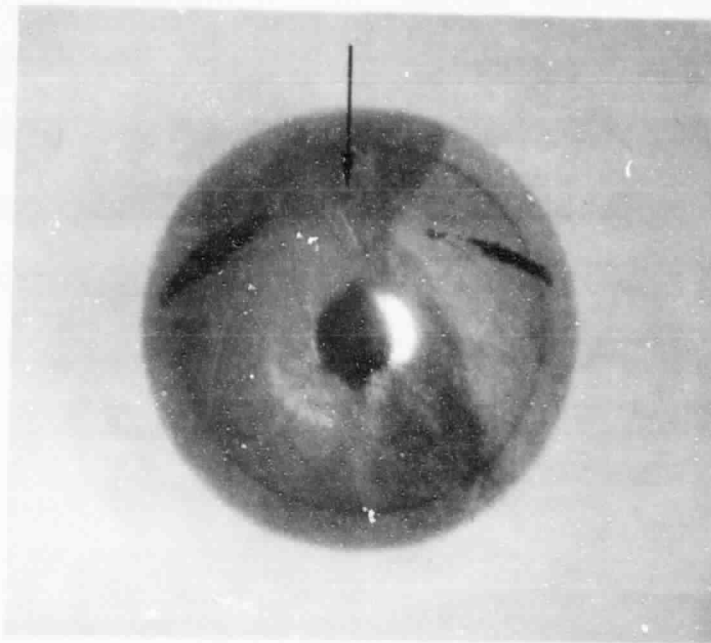
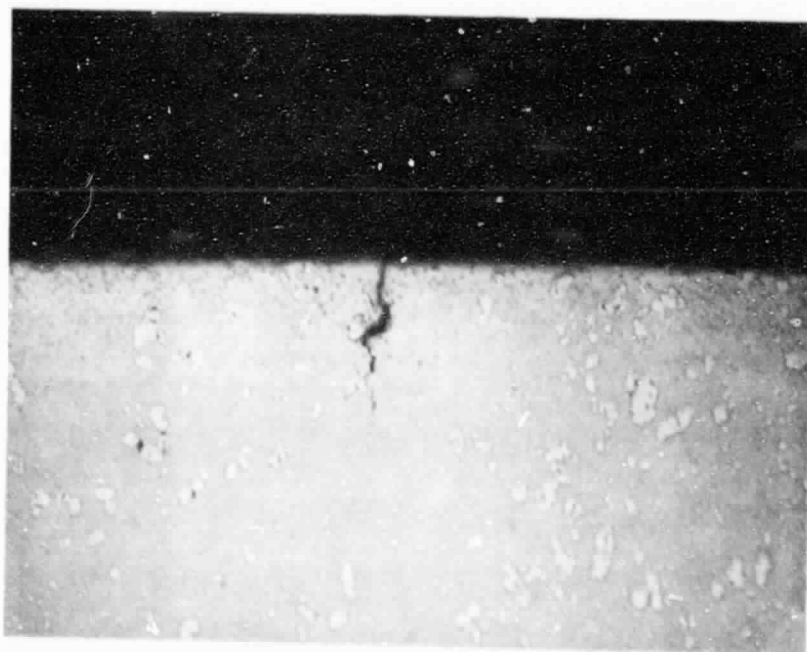
The crack in ball No. 2 (Fig. 5) appears to propagate nearly perpendicular to the surface. The reason for this kind of crack is not well understood. It is possible that this was a preexisting crack.

Figure 5. (A) Photograph of ball No. 2 from HPOTP 9008, Engine 2004. Note the surface crack. (B) Photomicrograph of section of ball through the crack. Crack depth approximately 0.05 mm (0.002 in.).

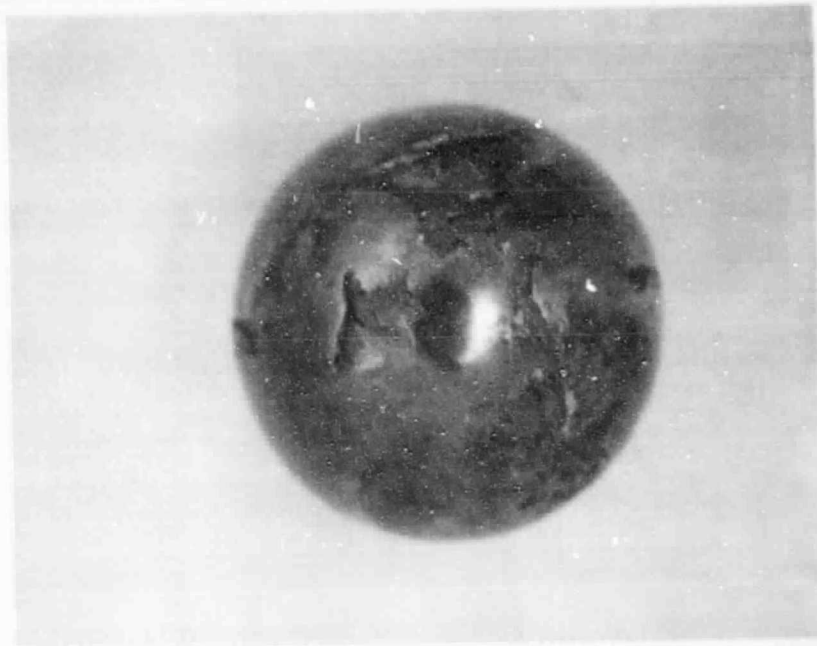
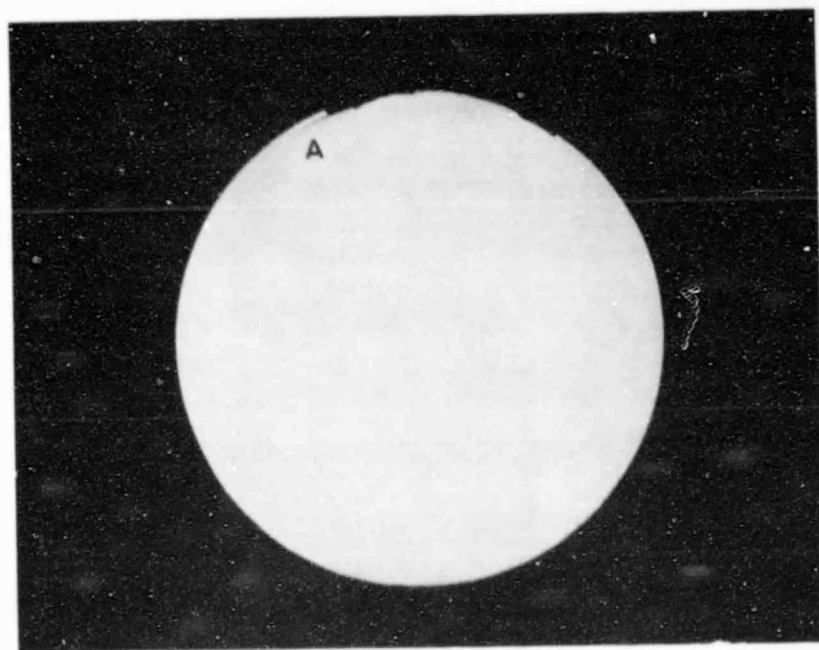
Figure 6. (A) Photomicrograph of ball No. 3 from HPOTP 9008, Engine 2502. (B) Cross section of the ball at top. Photomicrographs of this ball are shown in Figures 7 through 11.

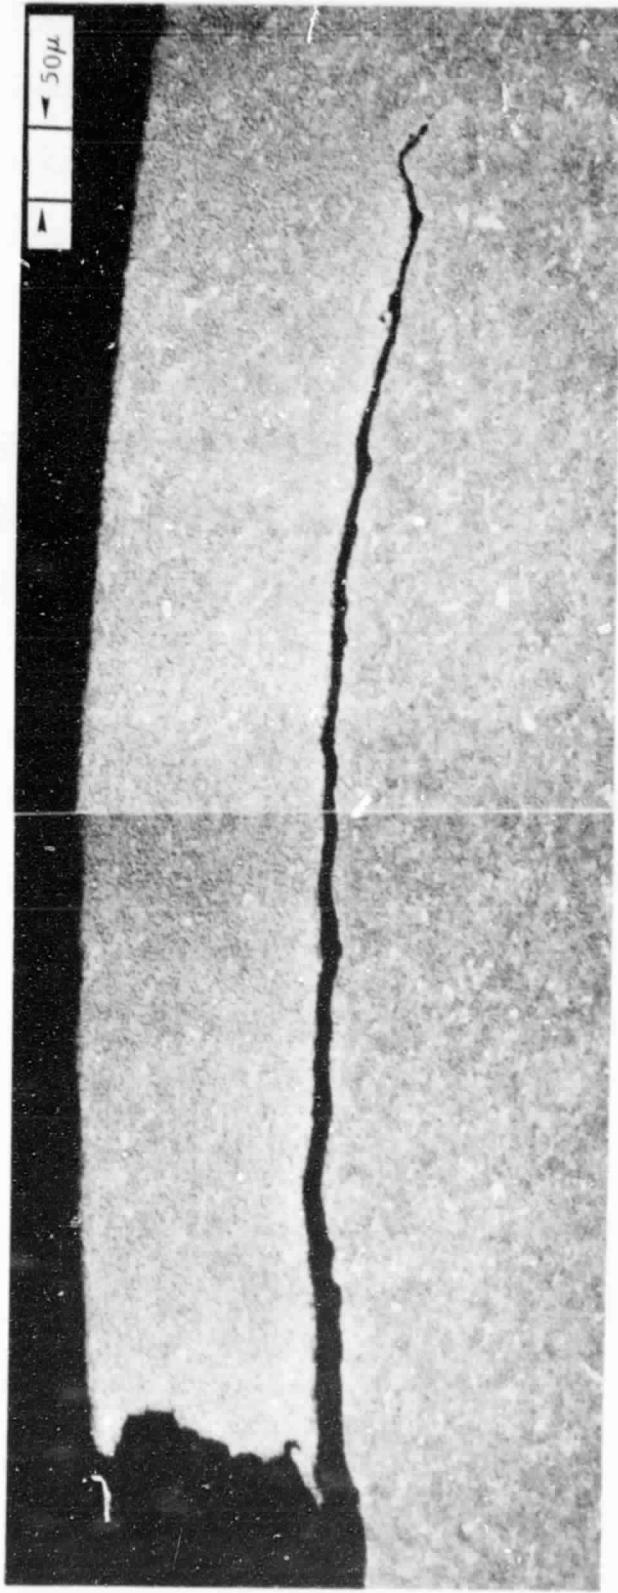
The crack in ball No. 3 (Fig. 7) appears to run parallel to the ball surface and is approximately 0.18 mm (0.007 in.) deep. The fracture at the spalled edge is nearly perpendicular to the surface. This crack configuration is consistent with a subsurface crack initiated under high Hertzian stresses, ≈ 3.8 GPa (550 ksi) [3]. The crack in Figure 8, on the other hand, appears to have initiated at a shallow spall (at the upper right hand corner of the Figure), and propagated inward at an increasing angle. Figure 9 shows a more advanced stage of spalling in which some material from the surface has been removed and cracks have propagated deeper inside. The deep crack has two branches at right angles and both appear to be at approximately 45° to the surface. This type of crack pattern could be a result of concentrated loading [8]. Another example of a 45° crack pattern is shown in Figure 15. Here again, the crack appears to have originated at a shallow spall and propagated inwards at an increasing angle. The branches are at 90° to each other and at 45° to the surface.

Figure 7. Crack in spalled ball from HPOTP 9008 bearing in Engine 2502 (area A in Figure 6).

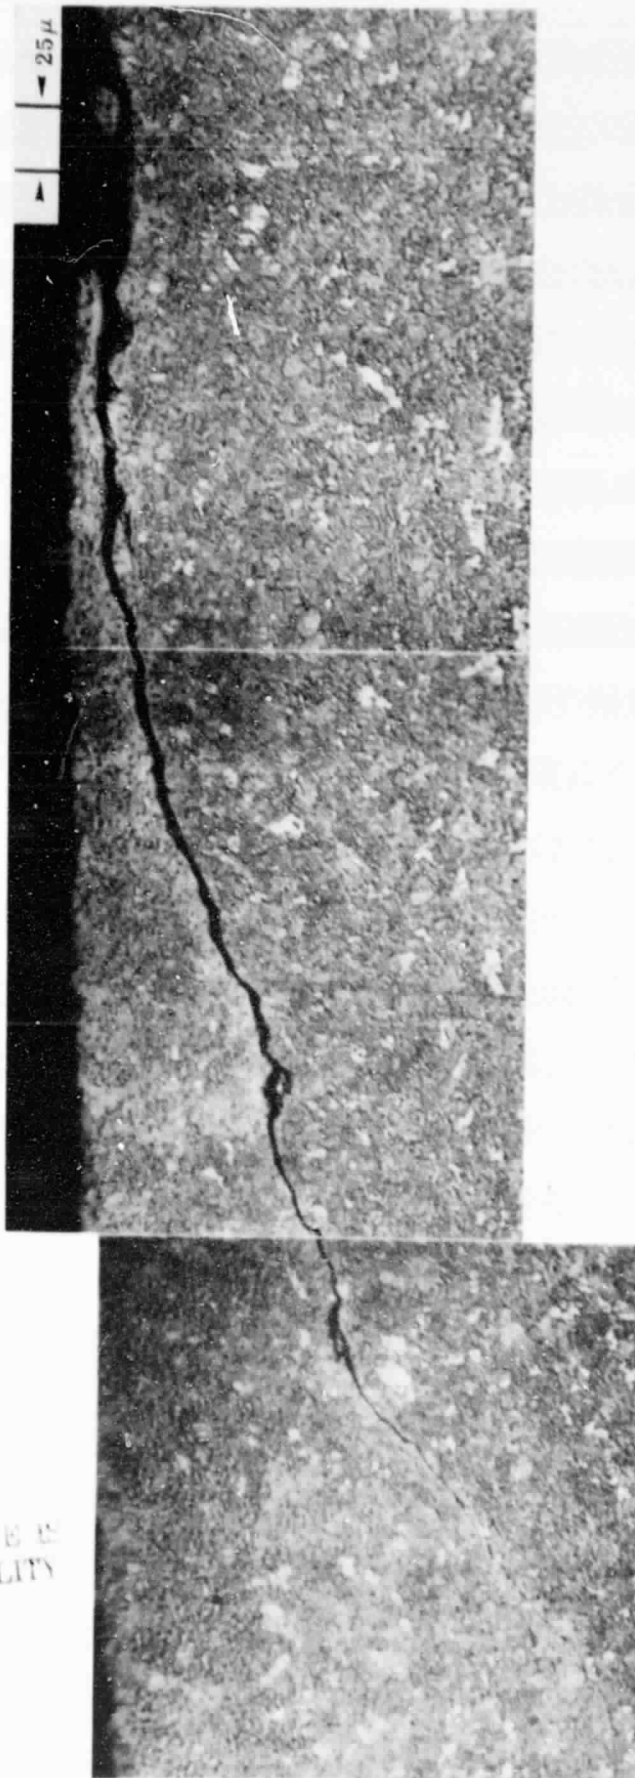
Figure 8. Shallow surface crack in spalled ball from HPOTP 9008 bearing in Engine 2502. Crack depth approximately 0.18 mm (0.007 in.).

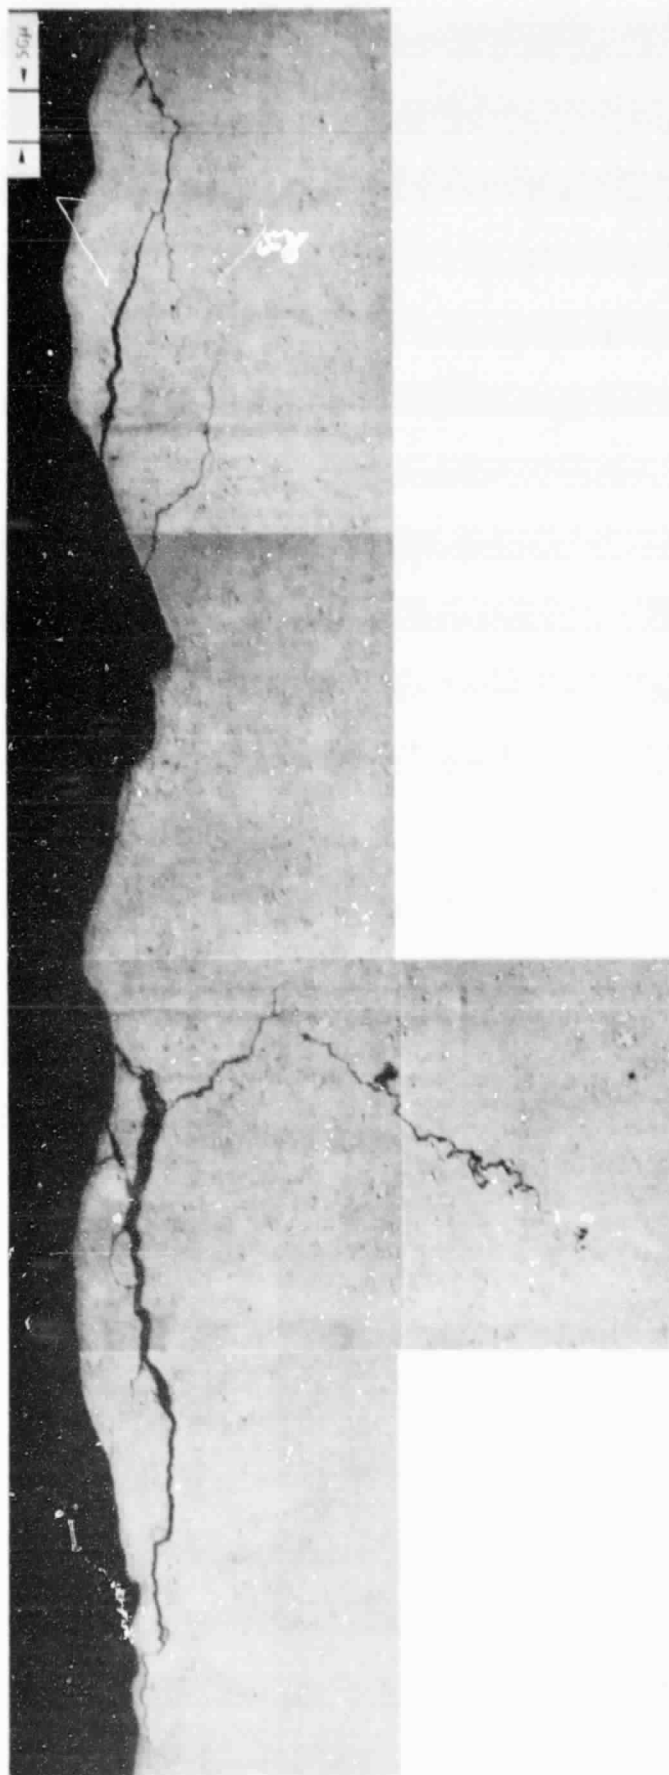
Figure 9. Cracks in spalled ball from HPOTP 9008 bearing in Engine 2502.

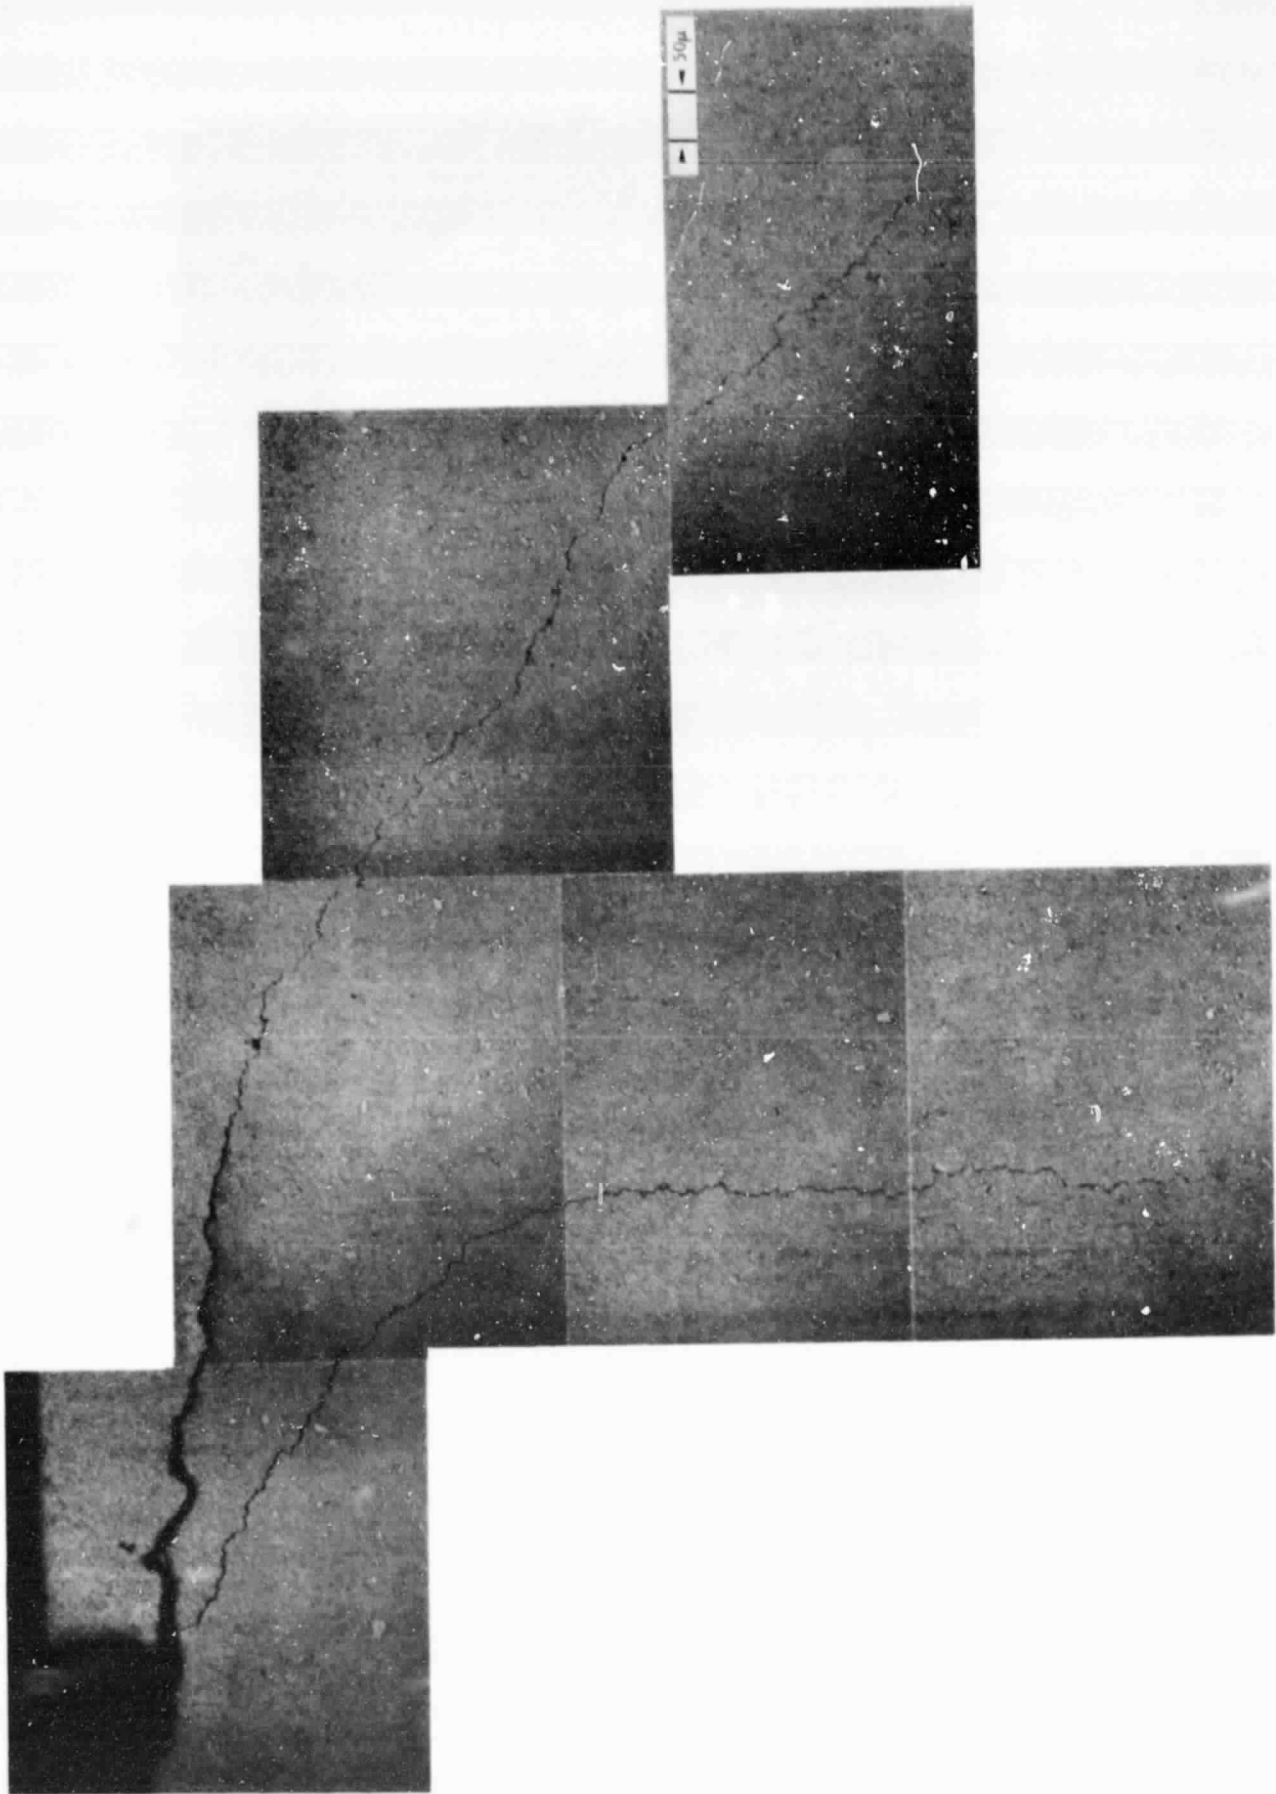
Examples of very deep cracks are given in Figure 11, 13, and 14 (balls No. 3 and No. 4). All these cracks appear to have originated in heavily spalled areas. The crack propagation patterns seem to follow the shear trajectories predicted by a stress model based on concentrated loading [8]. Further analytical work is needed to accurately predict the crack propagation patterns. TEM photomicrographs of a carbon replica of the fractured surface of the crack in Figure 13 are shown in Figure 16. This figure shows striations that are typical of crack growth by fatigue mode. The striation spacing is approximately 0.03μ . This spacing corresponds to approximately 75,000 cycles for the crack to grow to a length of 2.3 mm (0.090 in.). This result translates into approximately 15,000 revolutions or 30 sec of running time for the HPOTP at 30,000 rpm. The actual running time is difficult to predict and might be longer than the estimated 30 seconds, but the result suggests that crack propagation could occur in a relatively short time.

Figure 11. Deep cracks in spalled ball from HPOTP 9008 bearing in Engine 2502 (area A in Figure 10).

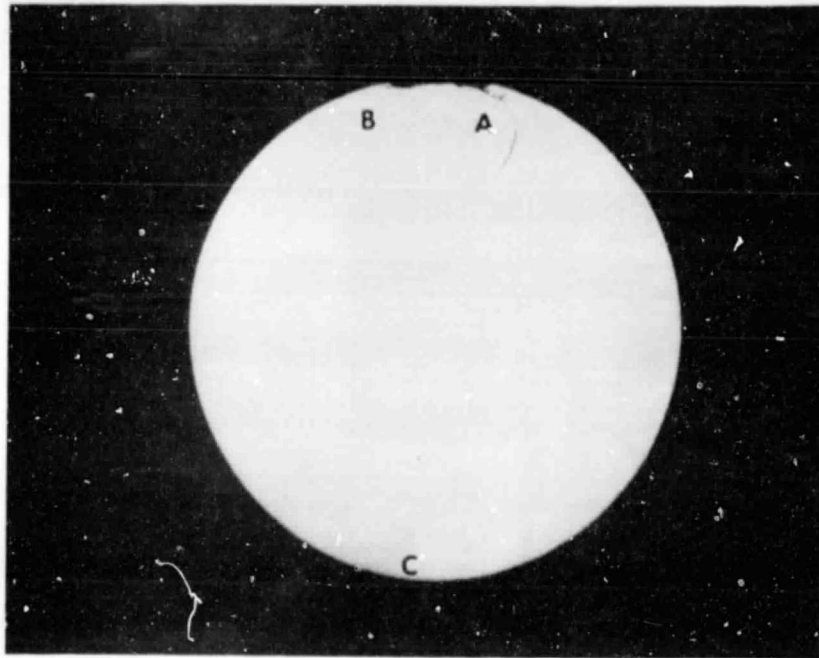
Figure 12 is a cross section of ball No. 4 from HPOTP 9008, No. 3 bearing from engine 2004. A deep crack, nearly 2.3 mm (0.090 in.) deep, is visible at area A. Figure 13 is a high magnification photomicrograph of a crack at area A in Figure 12. Figure 14 is a photomicrograph of a crack at area B in Figure 12. Figure 15 is a photomicrograph of a shallow crack in area C, (Fig. 12) away from the heavily spalled areas A and B. This crack appears to have originated at a shallow spall and then propagated inwards at a continuously increasing angle. Extensive branching has occurred with cracks meeting at approximately 90°. The cracks appear to be oriented at 45° to the surface. Significance of these angles is discussed in the next section.

Figure 12. Cross section of spalled ball No. 4 from HPOTP 9008 bearing from Engine 2004. Cracks in areas A, B and C are shown in Figures 13, 14, and 15 respectively. Original magnification 5X.

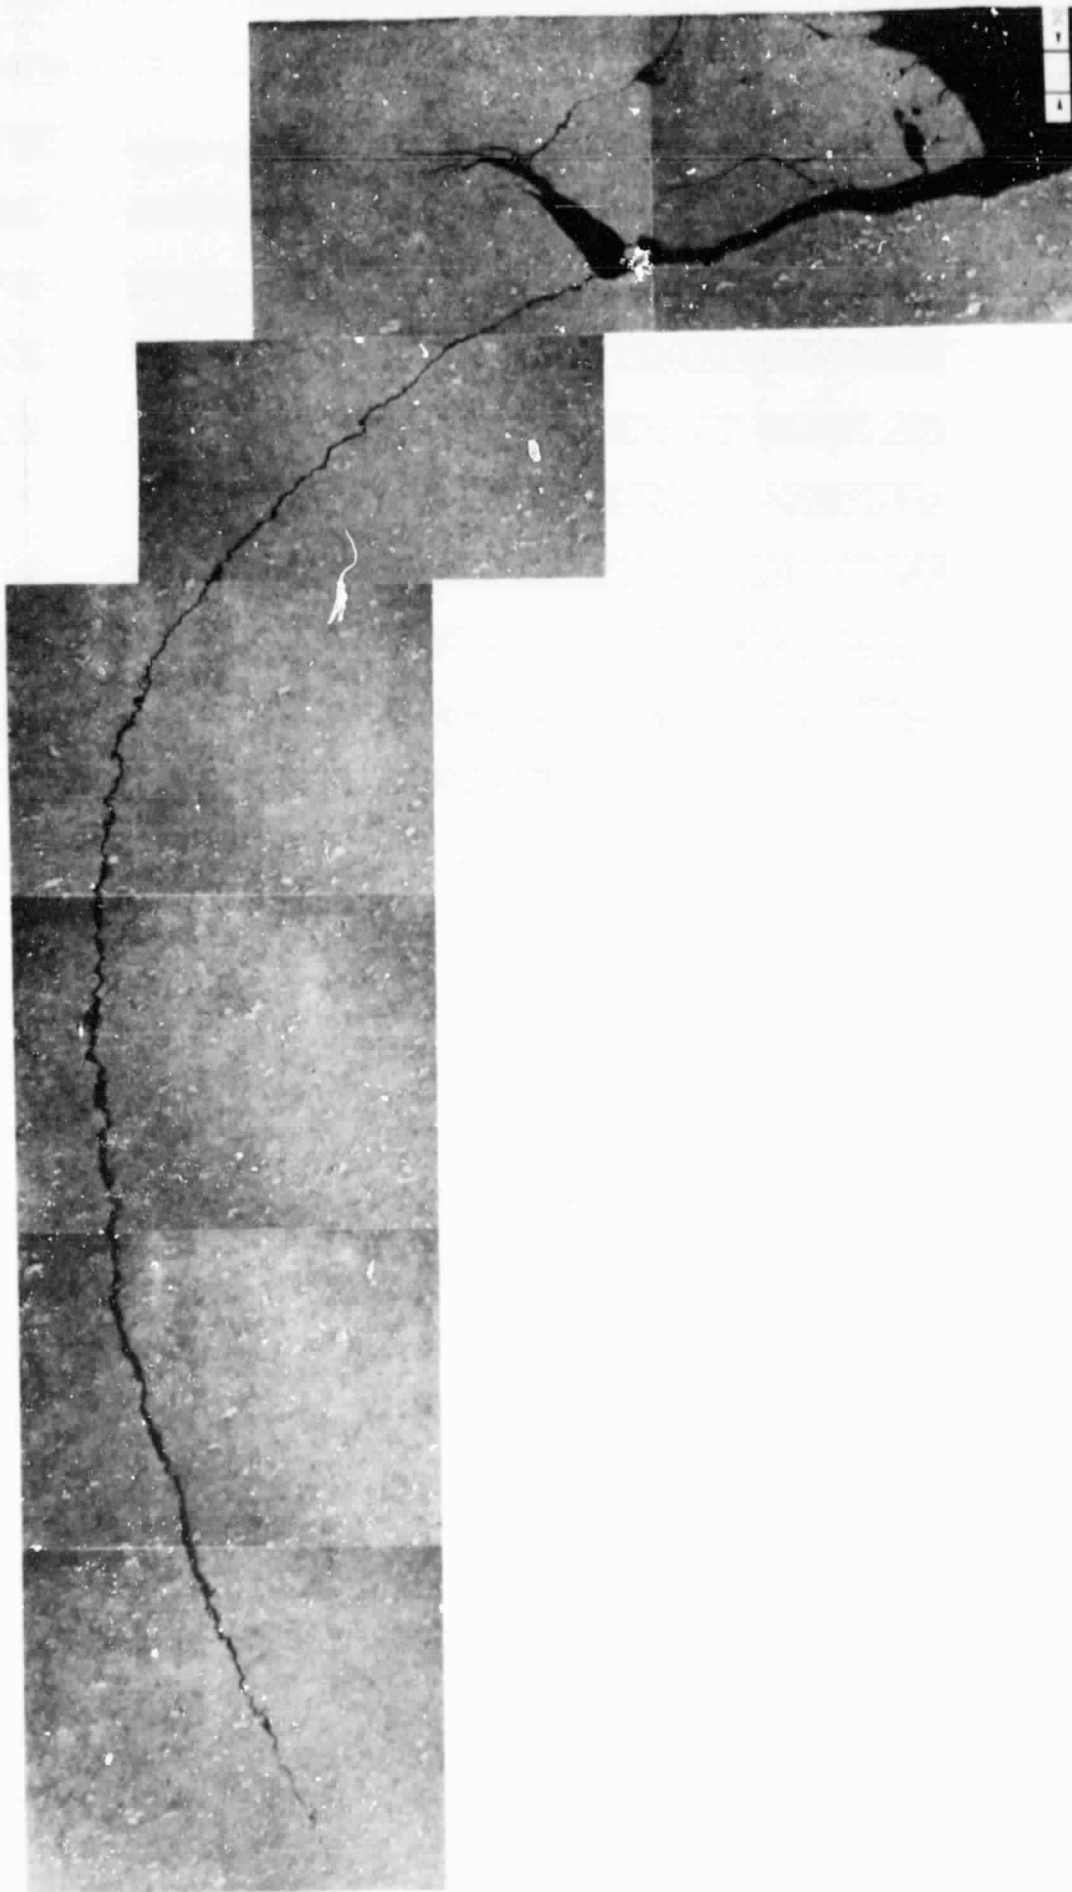
Figure 13. Deep crack in HPOTP 9008 bearing ball from Engine 2004. Crack depth approximately 2.3 mm (0.090 in.) (area A in Figure 12).

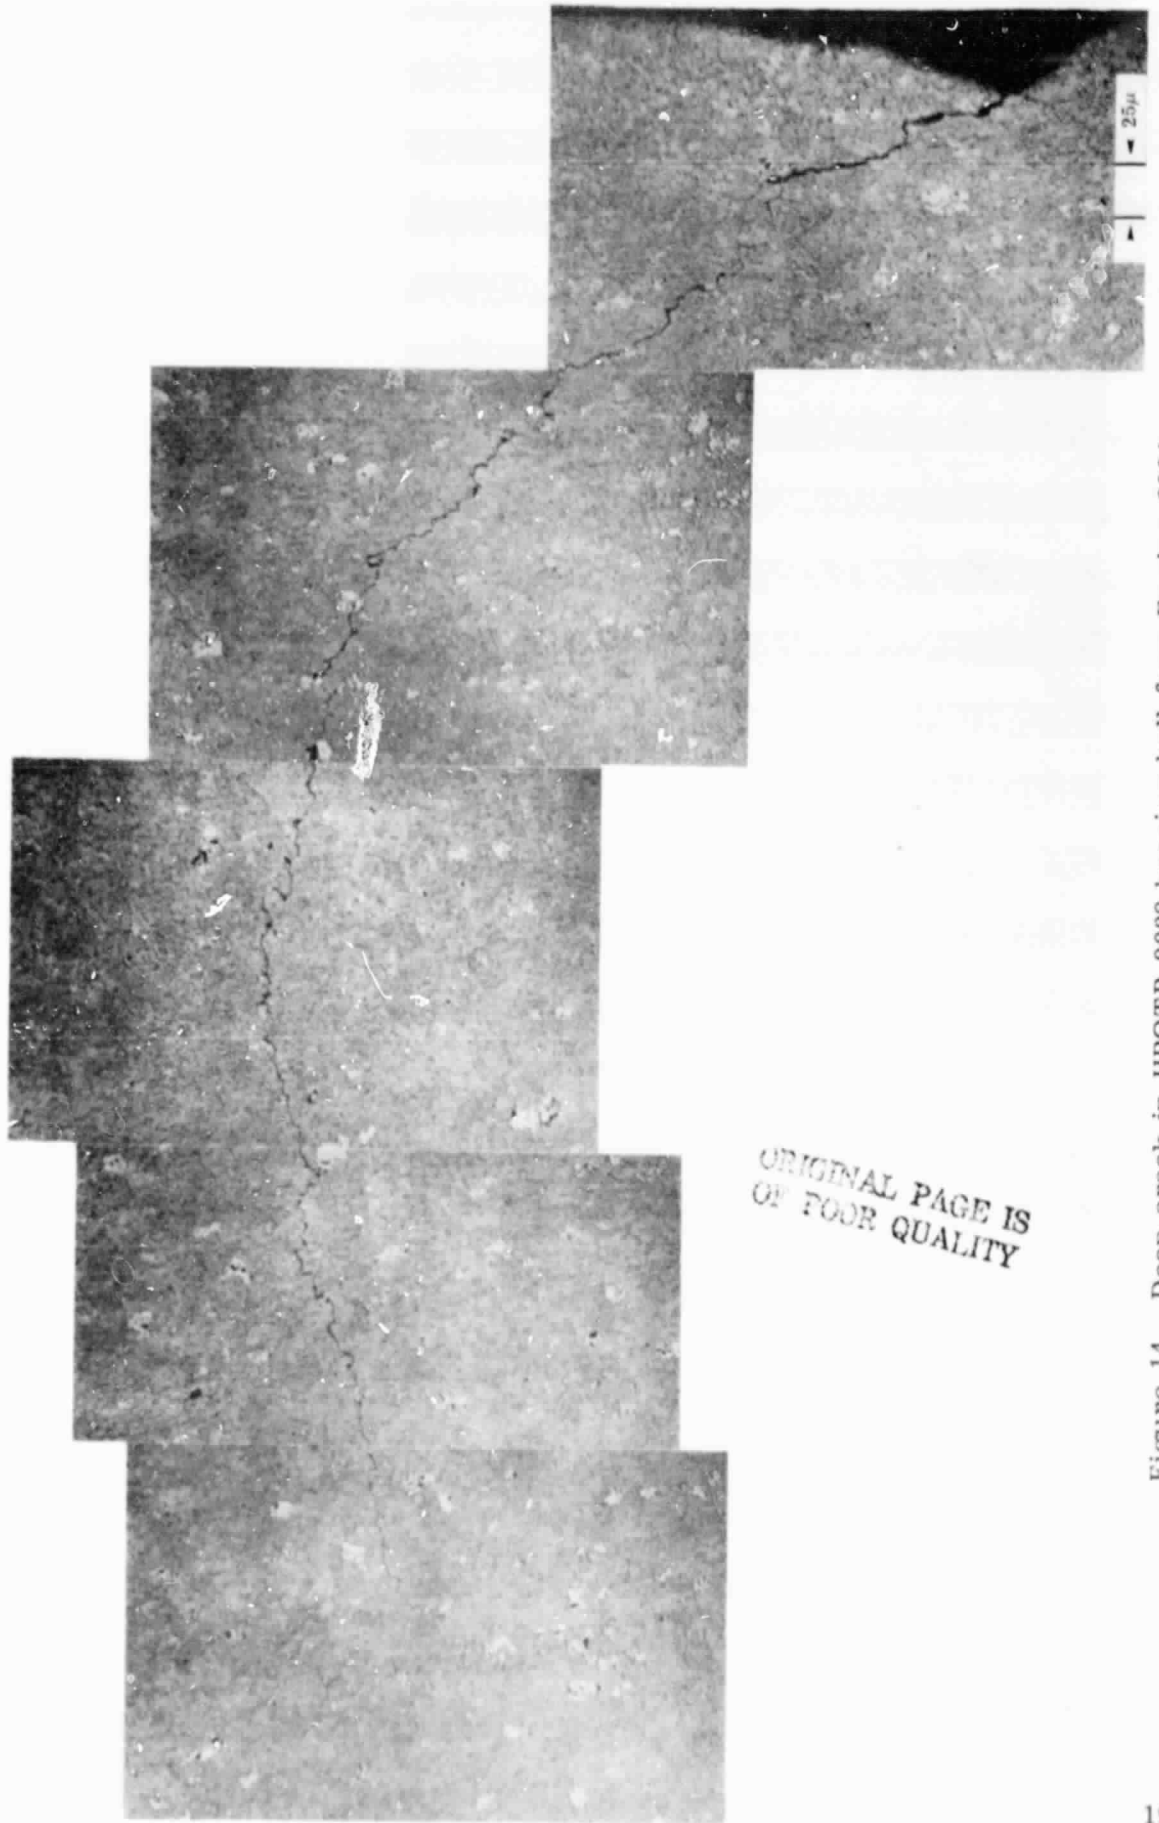
Figure 14. Deep crack in HPOTP 9008 bearing ball from Engine 2004.
Crack depth approximately 0.76 mm (0.030 in.) (area B in Figure 12).

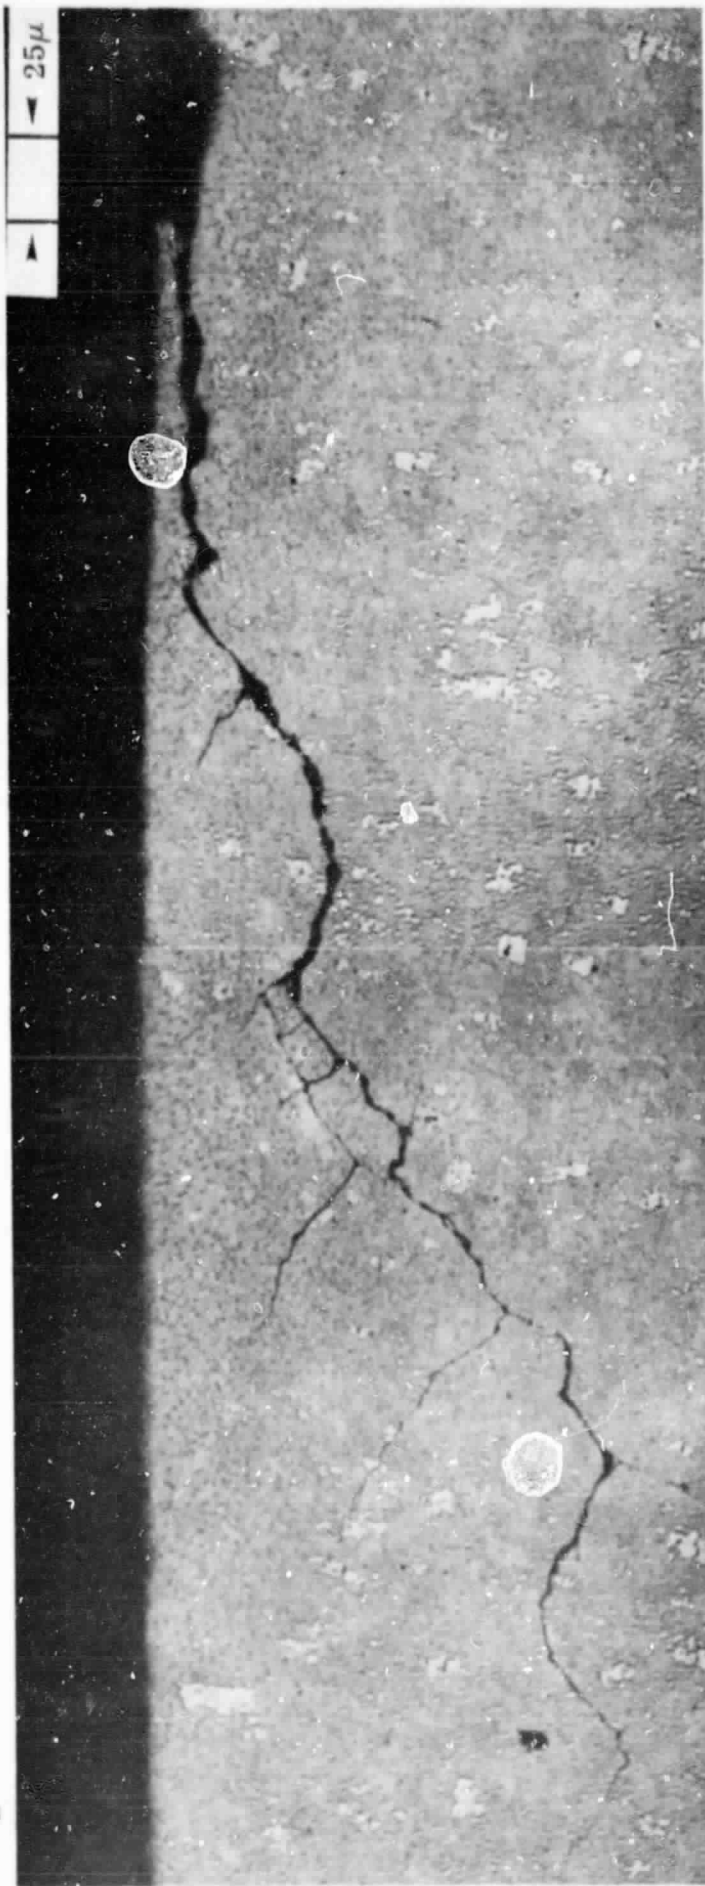
Figure 15. Shallow crack in HPOTP 9008 bearing ball from Engine 2004.
Crack depth approximately 0.13 mm (0.005 in.) (area C in Figure 12).

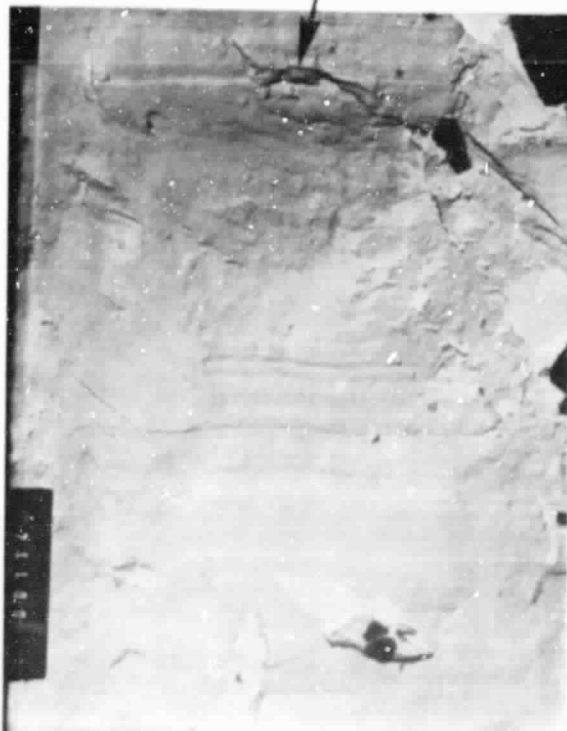
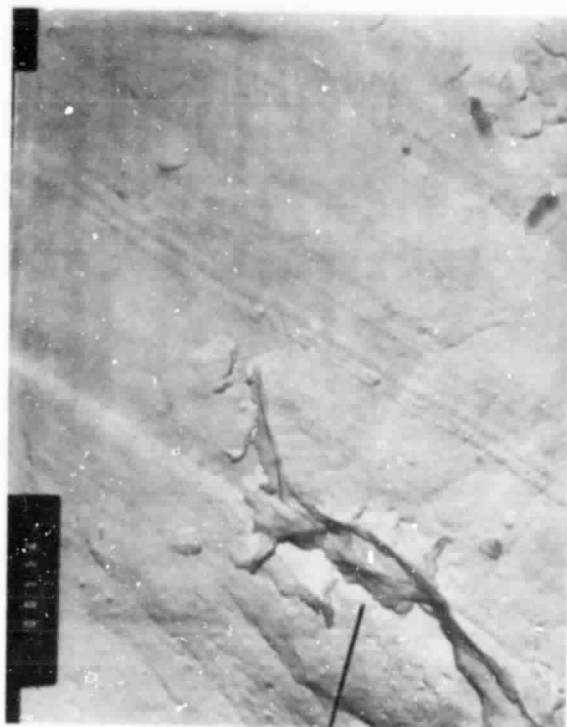
The crack A in Figure 12 was opened and the fractured surface was carbon replicated for examination in the transmission electron microscope. Two TEM photomicrographs of the fractured surface are shown in Figure 16. Parallel lines, resembling fatigue striations, are observed. Such striations were observed in different parts of the fractured surface.

Figure 16. TEM photomicrographs of fractured surface in HPOTP 9008 bearing ball from engine 2004. (Fractured surface from crack A in Figure 12).
